# SERVICE BULLETIN

from: TRIO-KENWOOD COMMUNICATIONS, INC.

TS-120S

SUBJECT: TS-120S ANT INPUT TRANSFORMER REPLACEMENT

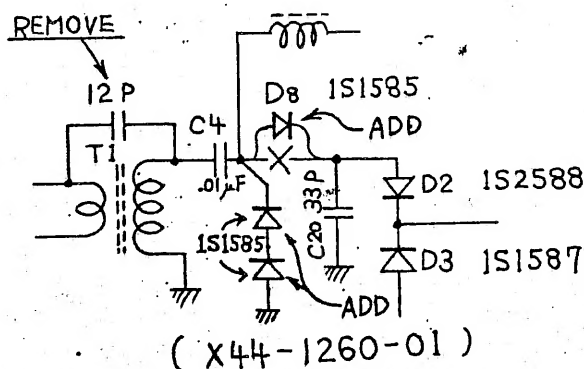
Transceivers subject to strong static fields, high RF, or similar high current atmospheric discharges may suddenly exhibit low sensitivity on all bands. TX will not be affected. Suspect T1 on the RF unit, X44-1260-01.

When replacing T1, L43,0696-35, check that the value of C20 is 33pf. Early units may have a 15pf for C20, and may have T1 as L43-0696-05. In either case, replace the transformer with an L34-0929-15. If C20 is 15pf, replace it with a 33pf capacitor. Since T1 is a broadband transformer, no adjustment is necessary.

In addition, add two 1S1587 diodes after the transformer as shown to further protect the receiver.
